Line 1 inspection report 13/05/2013

Line 63,000 bph

Bottle transport on stainless steel chain with water/soap lubrication

I. LB1 Inspection report

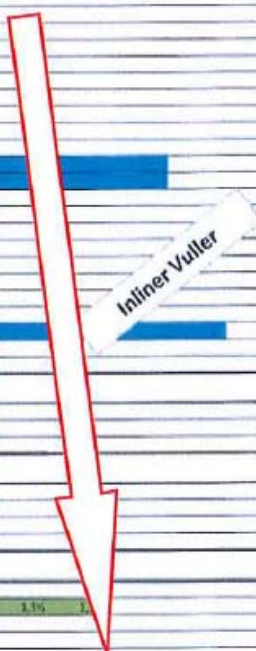
Inliner Vuller

Outliner Vuller

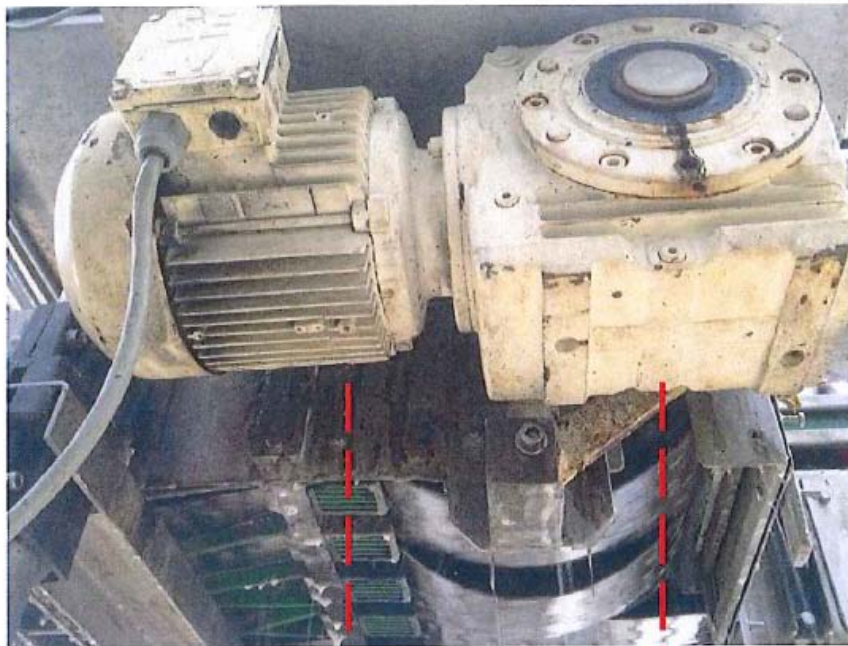
1. Slipping chains observed on the drive wheel: Causes the chain to jerk

Cause: catenary sag too small.

This is 200 mm on the pasteuriser drive outlet, i.e. M70 (below) and M71 (above).

200 mm = NOT OK

Our recommendation is 450 mm. See below.

It is recommended to create a catenary sag just behind the sprocket which provides a complete discharge of the chainload.

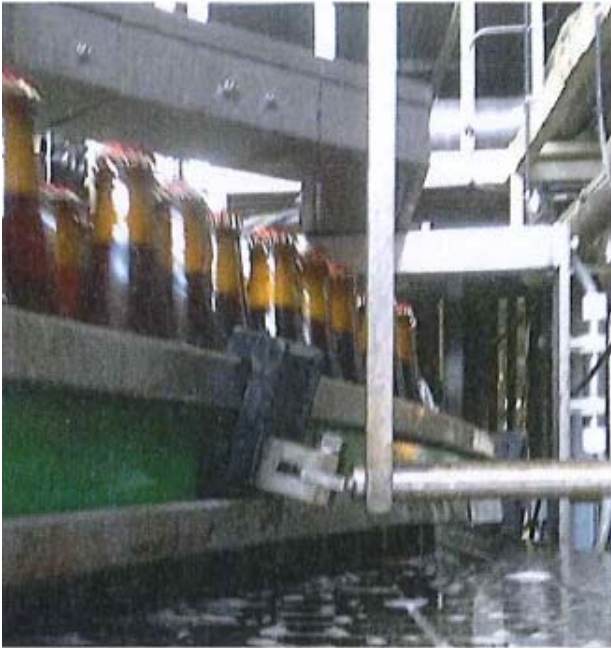
2. Side guides of the bottles

- The holder has broken off and the side guides are bent at some places.

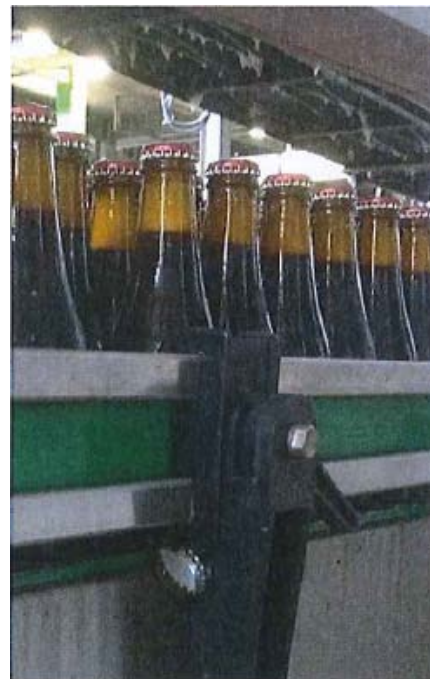
- Side guides must be parallel to the sides of the bottle.
Observed: the side guides are crooked at some places; due to this, pressure could cause the bottle to topple and possibly fall.

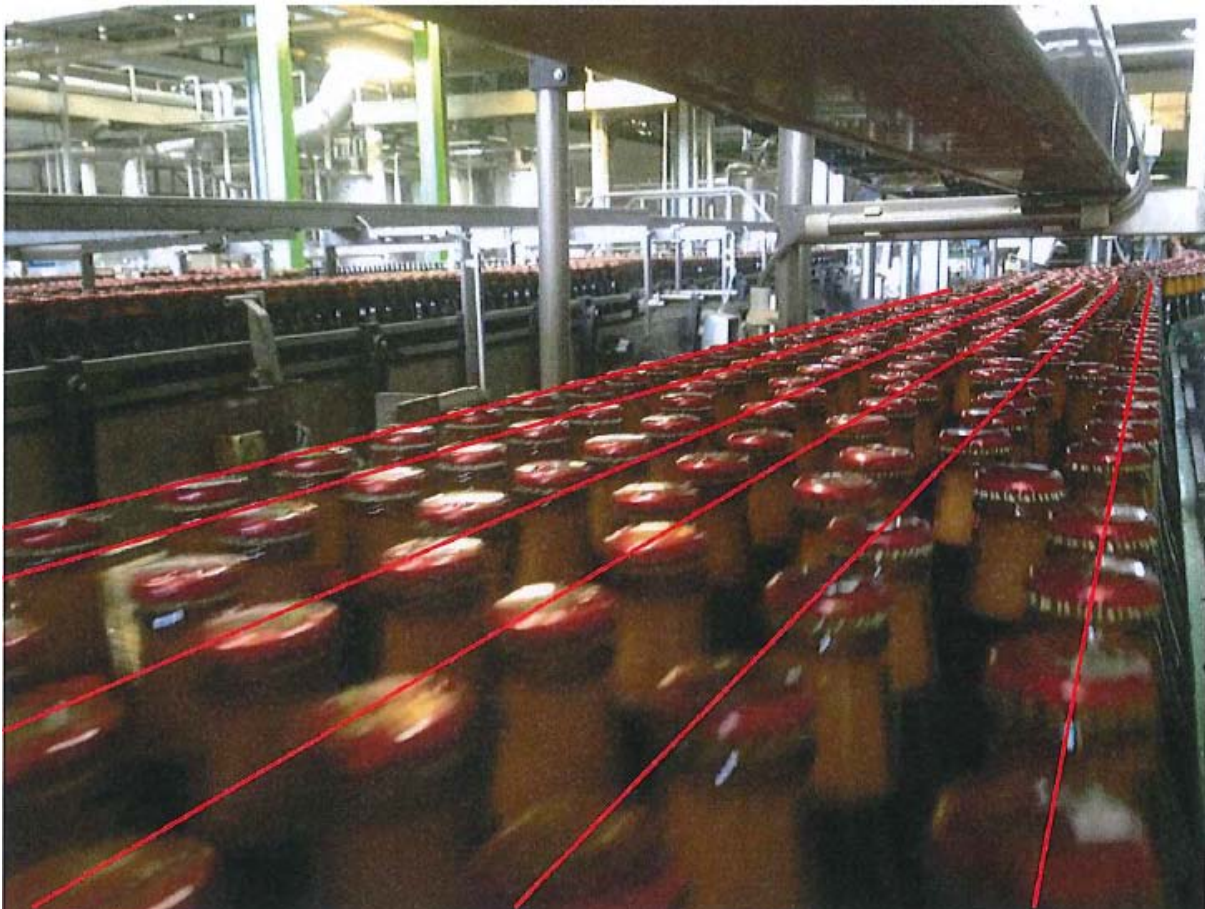
- Internal width of pasteuriser entrance above and below:

The side guides widen and narrow at some places, which could result in enormous pressure on the guide.

For a bottle with a diameter of $58.5 + 1.2$ mm and a 6-track chain conveyor, we calculate the ideal width for 6 tracks of bottles to be 323 mm.

This is an actual average of 335 mm.

Bottles not lined up -> side guides too wide

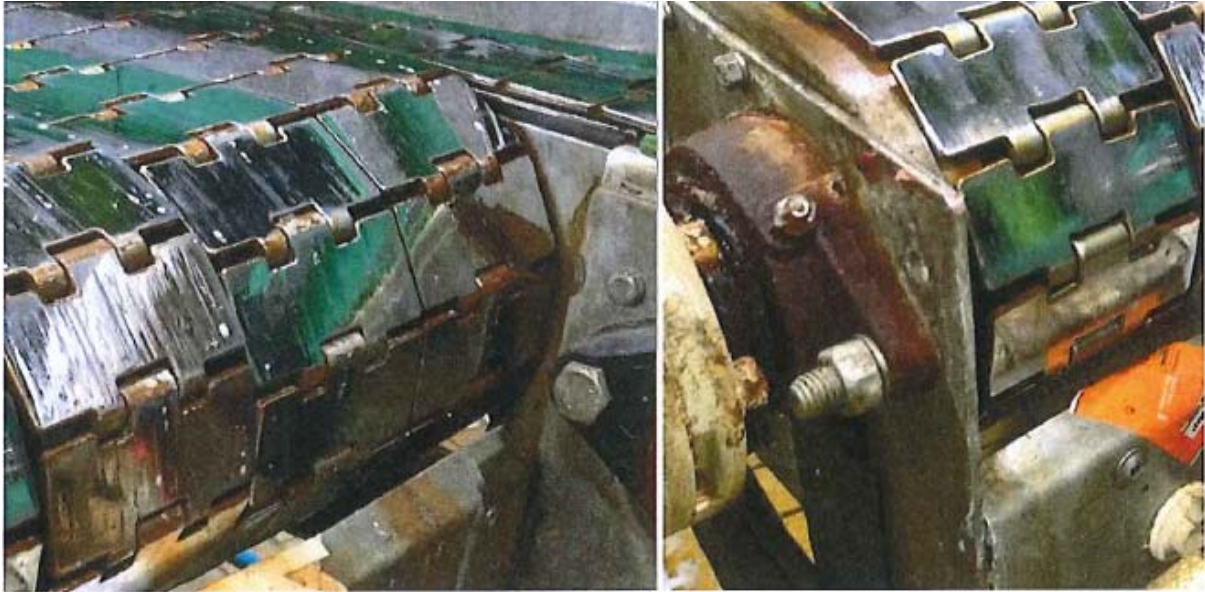
3. Corrosion:

At exit to the Etima we observed corrosion on the chain.

Reason: unknown - exposed to a chemical product??

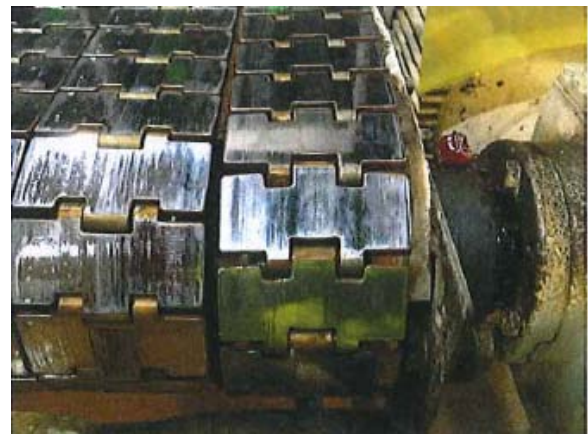
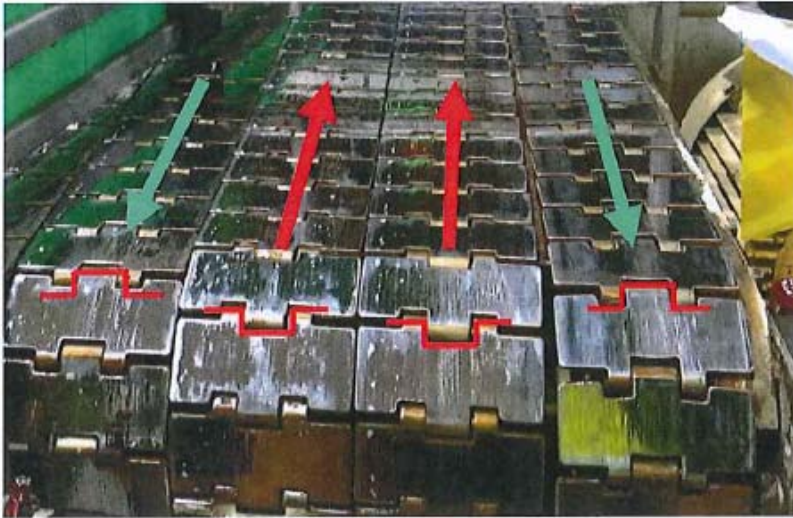
Chain is incorrect on 5 places;

Running direction is especially important at inliner and outliner zones -> greater likelihood of bottles falling over when they are in the wrong direction

- M 71 track 2
- M 79B - 1 1° for inliner chain Etima A
- M 79B - 4 4° for inliner chain Etima A
- M 81 2 middle tracks

Chains not all running in the same direction on M 81

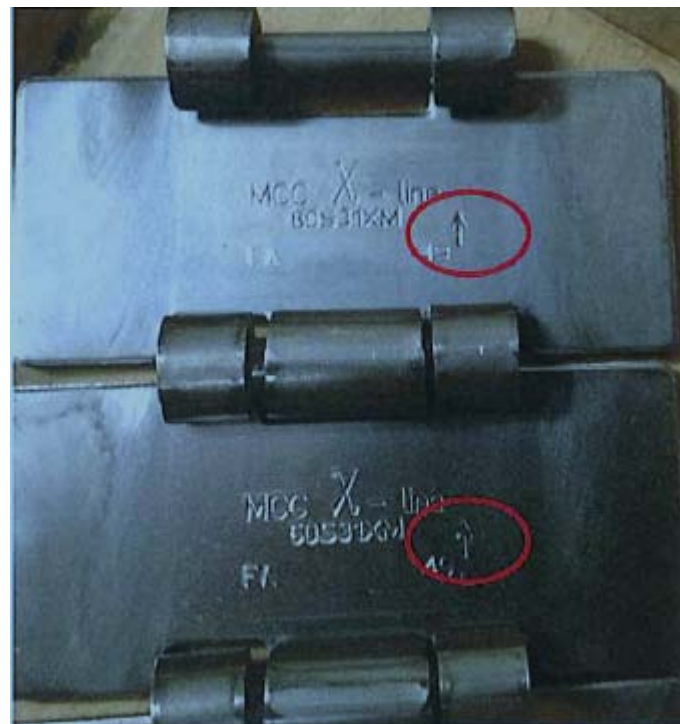
Chain running direction

Chains have a preferred running direction that is indicated with an arrow on the underside of the chain.

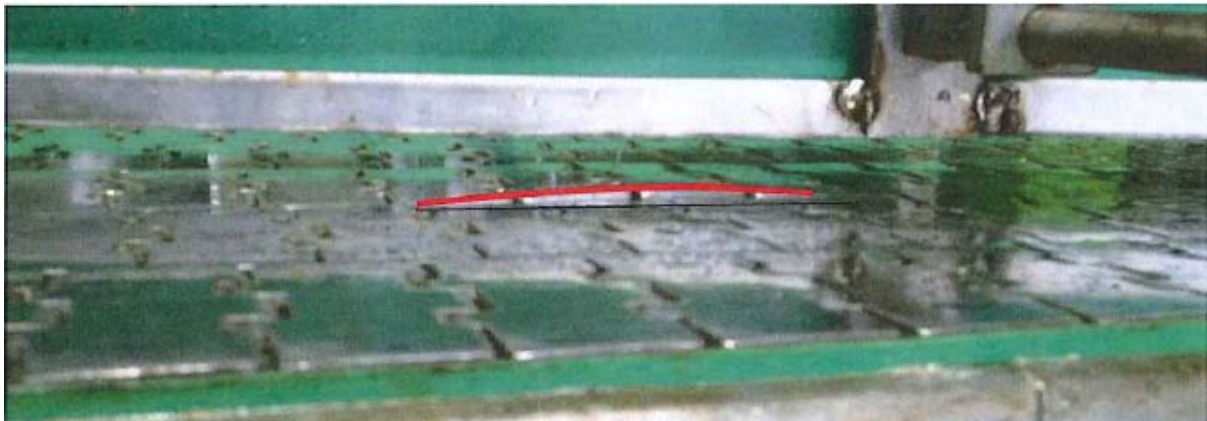
5. Contamination under chain:

Contamination was observed at outliner Filler motor M83-3 3° between the chain and lower guides. This causes the chain to raise at these places.

This is a cause of bottles falling over, certainly in this zone.
